The Nose Knows: Canine Scent Tracking

Canine Scent Tracking A Case Study

**Grand Traverse Bay Watershed
Healthy Beaches Program**

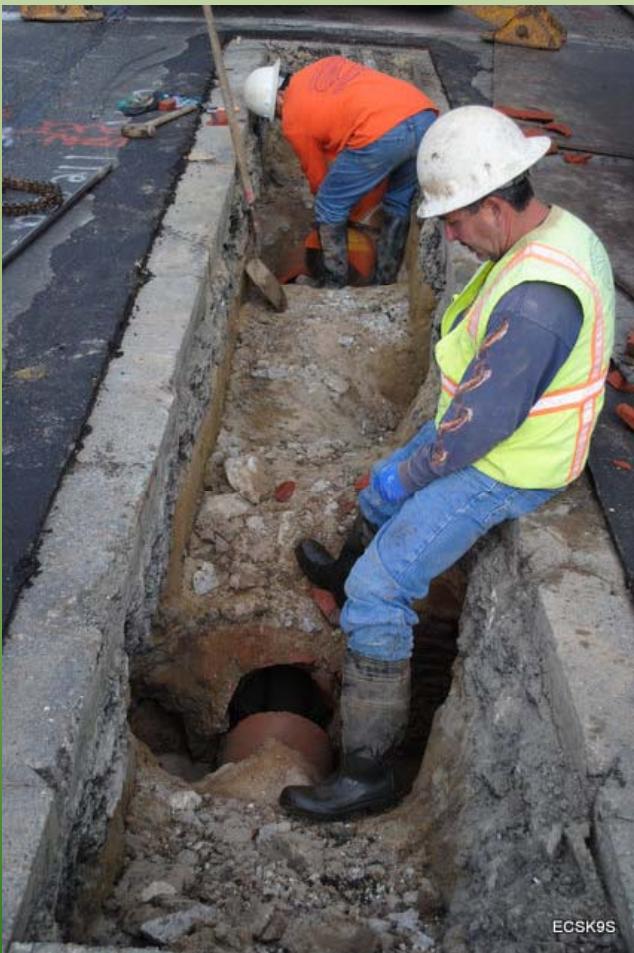
- Hope Drain Diversion
- Arroyo Burro Beach
 - AKA Hendry's Beach
- Real time results
 - “positive results from K9s lead urgency to situation leading research team and city workers to uncover a leaking sanitary sewer”

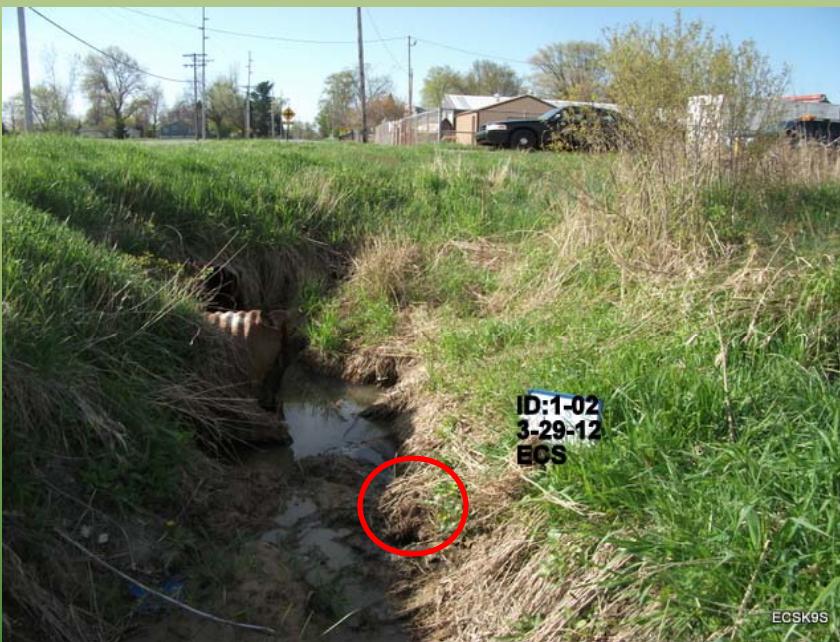
Three Oaks, MI

- Walking roadside ditches
- Checking all input pipes, catch basins, and seeps
- Ditches flow to tributaries of Galien River

Facing south- flows south

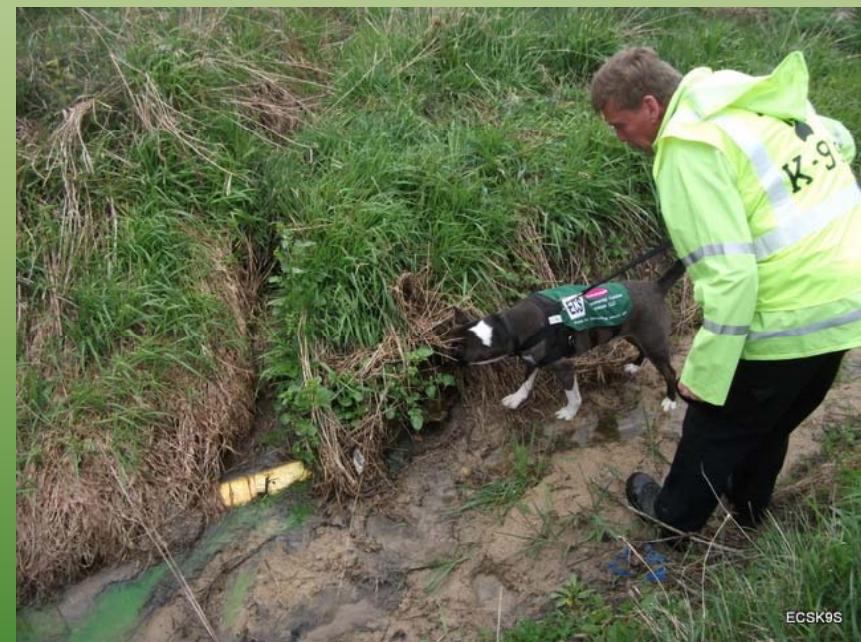
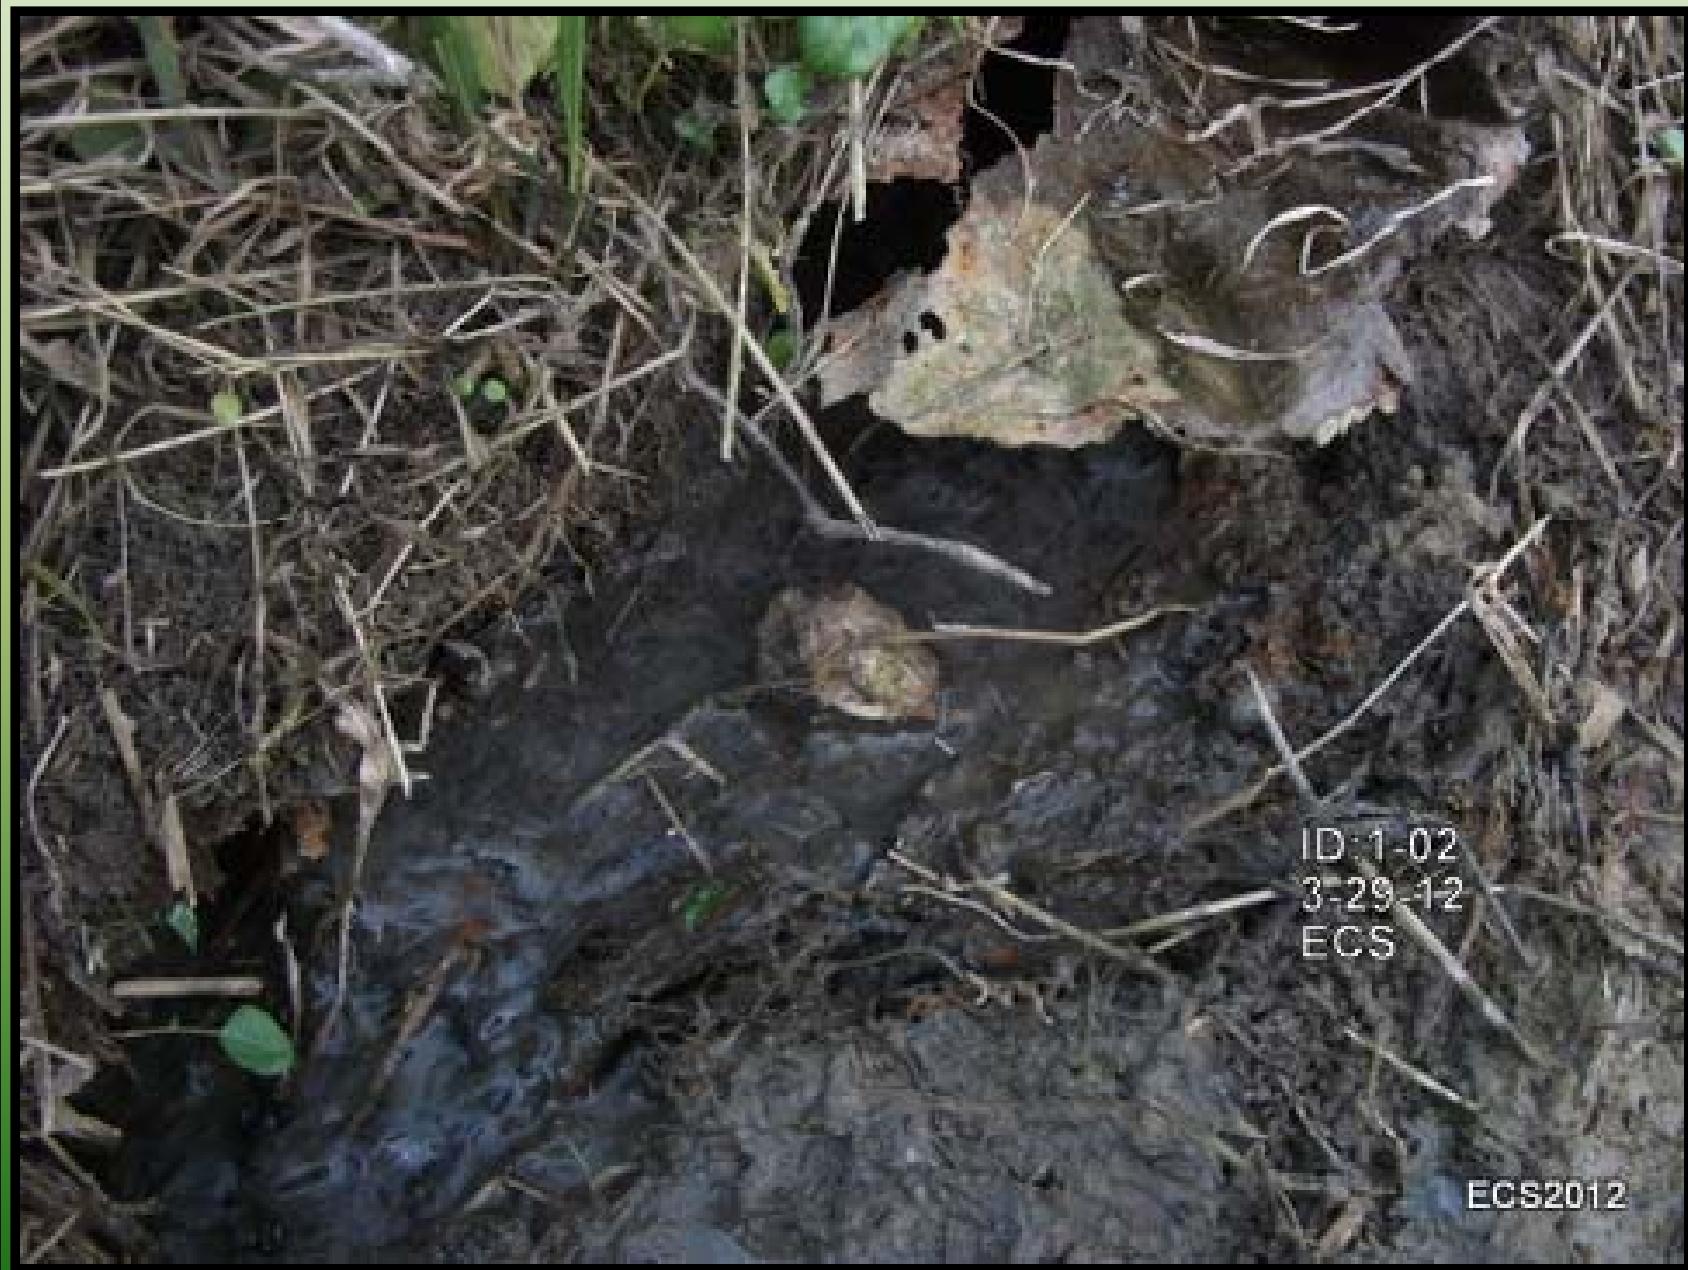
ID: 1-02
3-29-12
ECS

- Residential septic connected to farm field tile
- Recent rains washed away physical evidence and odors
- Dye test confirmed
- Berrien Co. HD “ we never would have found it without the dog”.

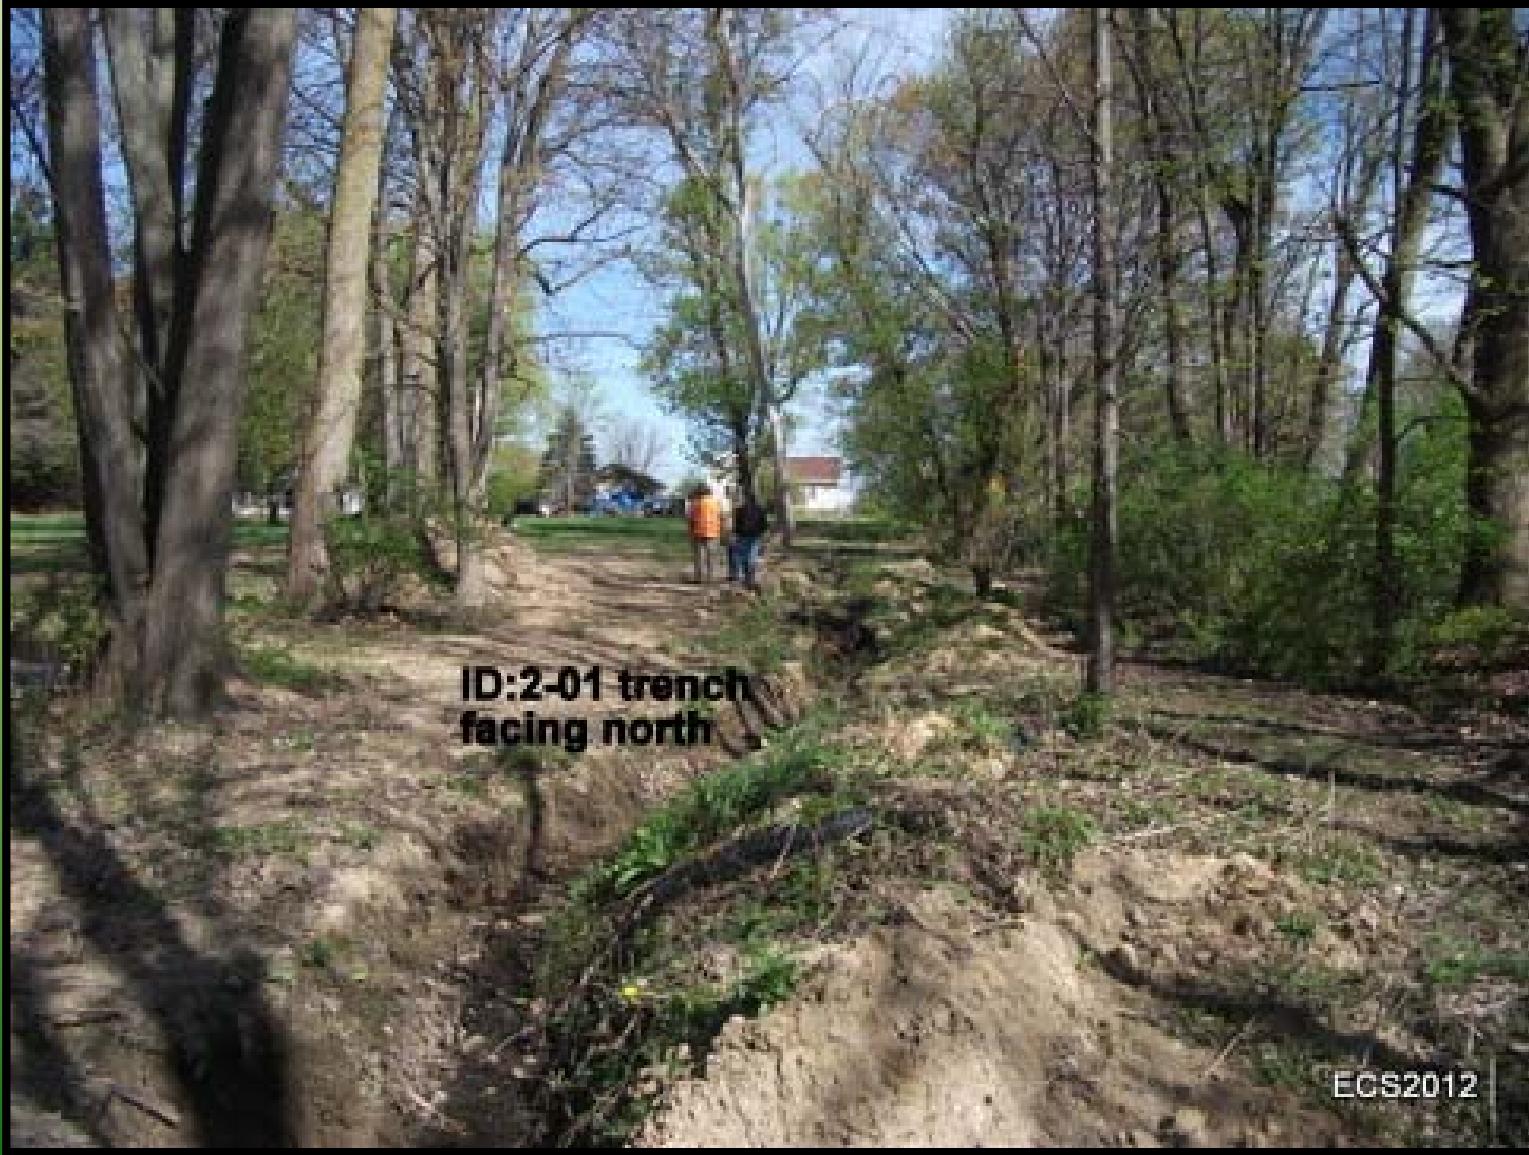
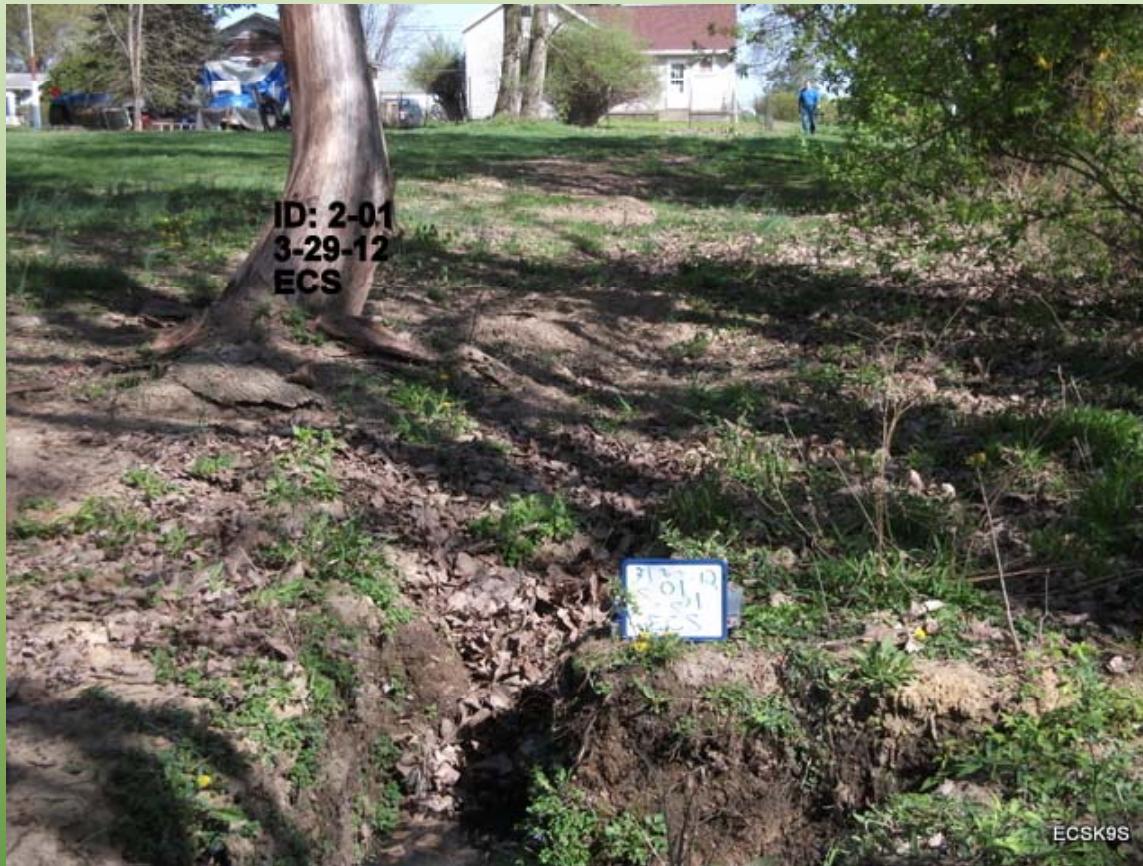
Residential Septic to Wetland

“Always been that way since we bought it”.

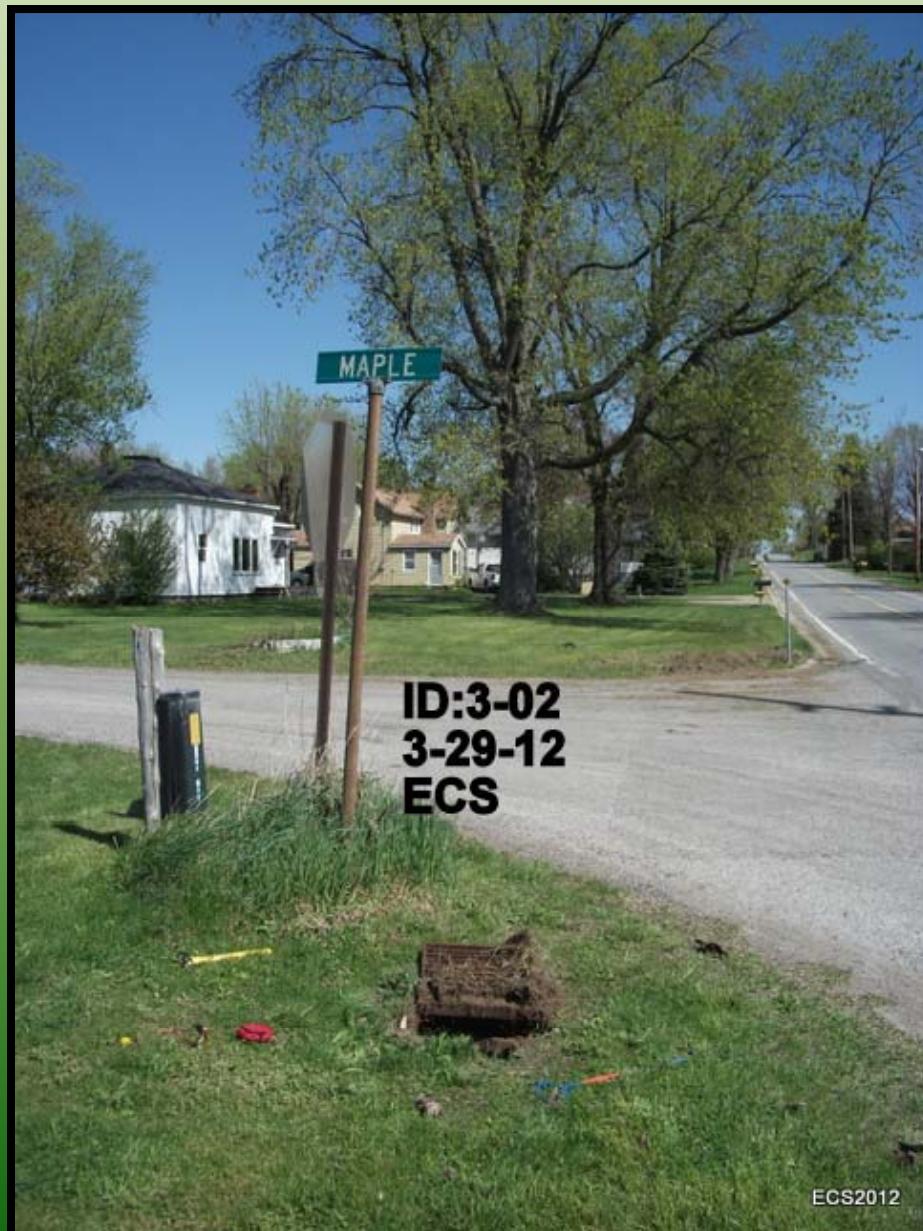
**ID:3-02 Interior facing east
sanitary staining**

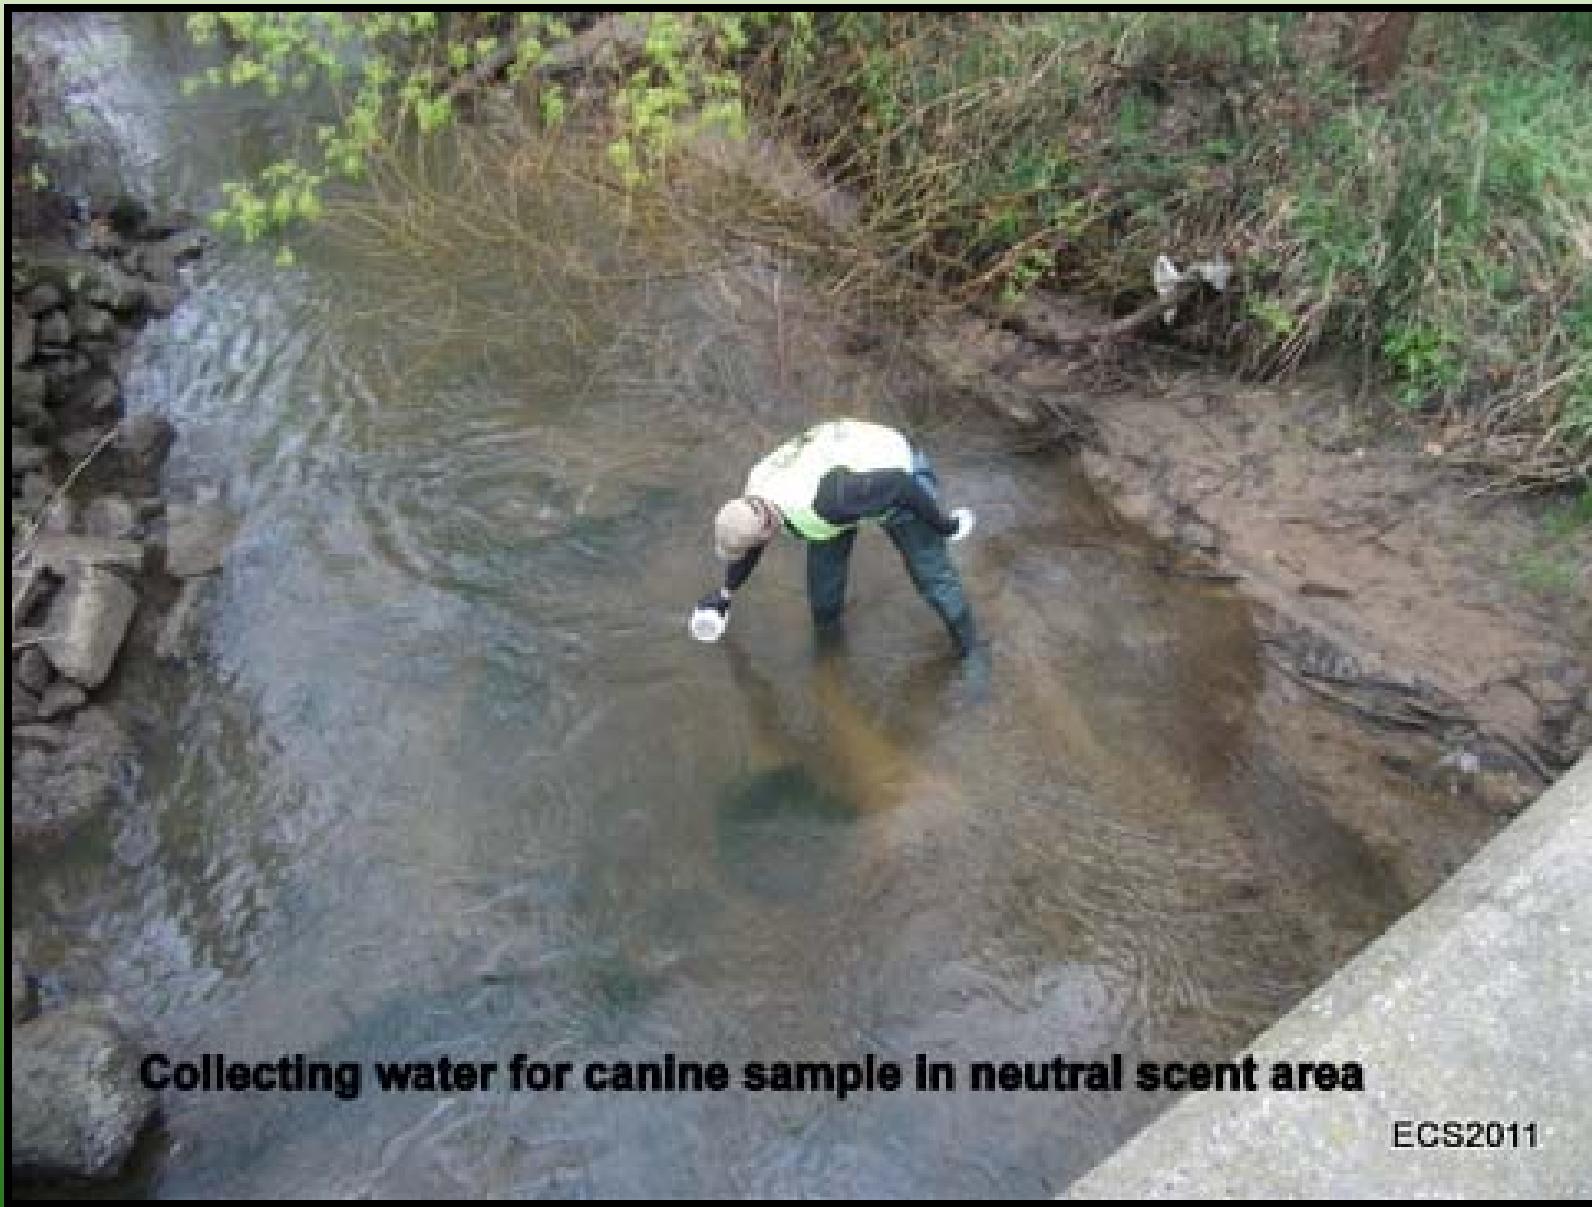
Collecting water for canine sample in neutral scent area

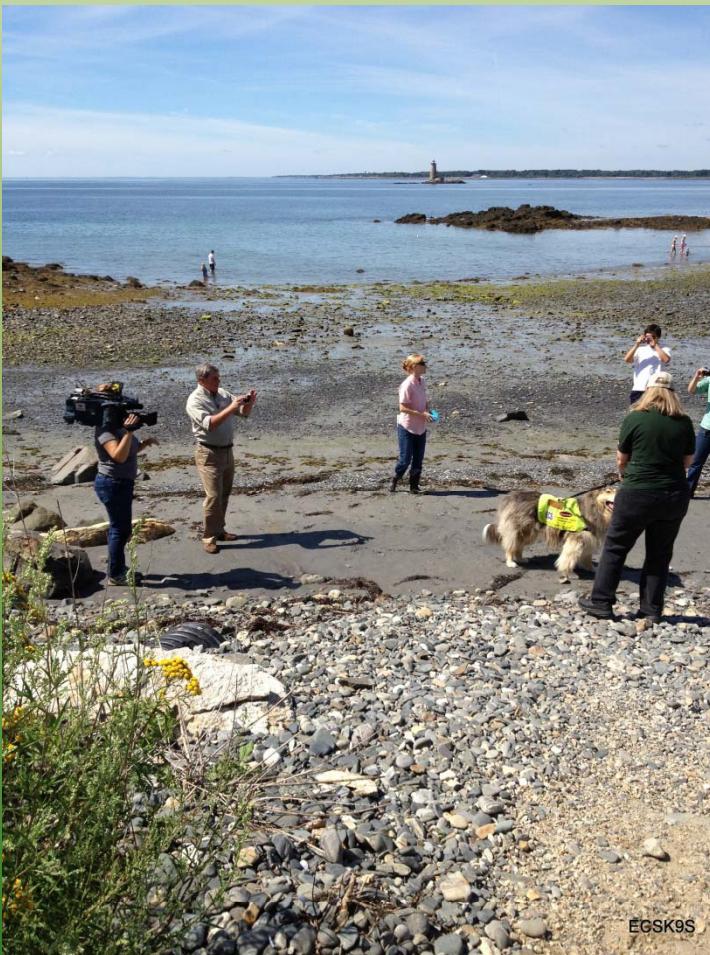
Coast Lines

- Coast line seeps at low tide
- Lead to discovery of old outhouse with drain pipes
- A bathhouse shower draining to beach
 - “Rub-a-dub”

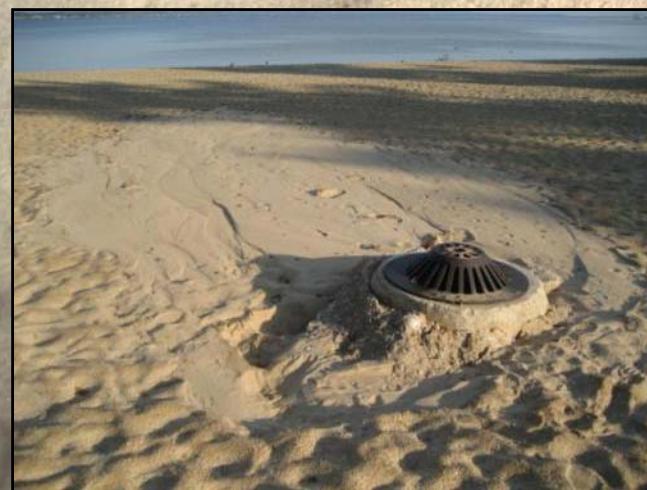
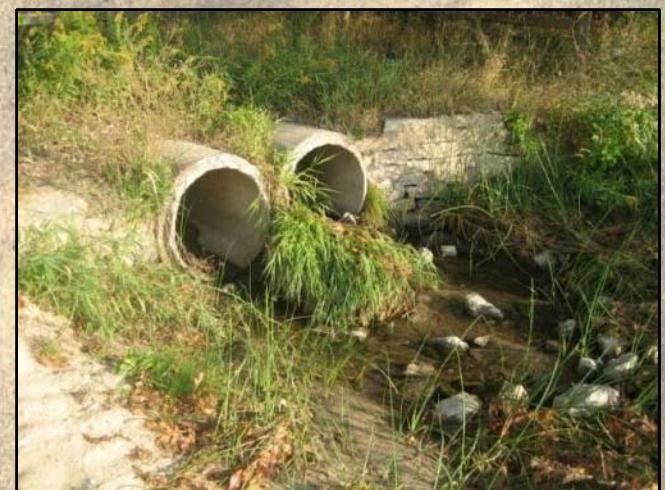
**Two problem drain outlets
at beaches:
Bryant Park (left),
East Bay Park (right)**

- **Conducted EPA Sanitary Surveys at local beaches**
 - Identify known and potential sources of bacterial contamination
 - Assess the magnitude of pollution
 - Identify priority locations for water testing
- **Findings**
 - Most beaches with elevated E.Coli bacteria levels were being impacted by storm drains either at or nearby the beach
 - Samples from storm drains revealed E.Coli levels between 10,000 and 30,000 col/100mL... that's a lot!

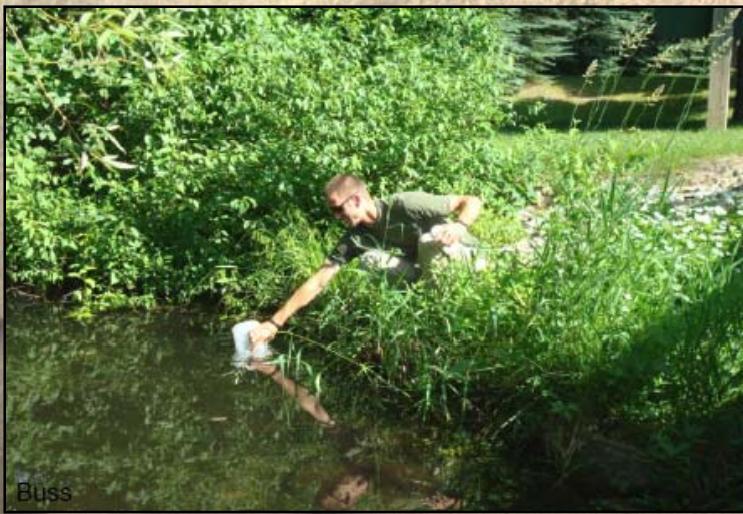
MSU grad student taking water sample of Mitchell Creek

- Samples taken in 2009/2010 – results at least 6-9 months later
- Analyzed for human pathogens and gene markers
- Samples taken at beach, drain outlets, and nearby creek
- Positive results for human sources of fecal contamination found
- MSU project cost \$50,000+ (our cost ~ \$10,000)

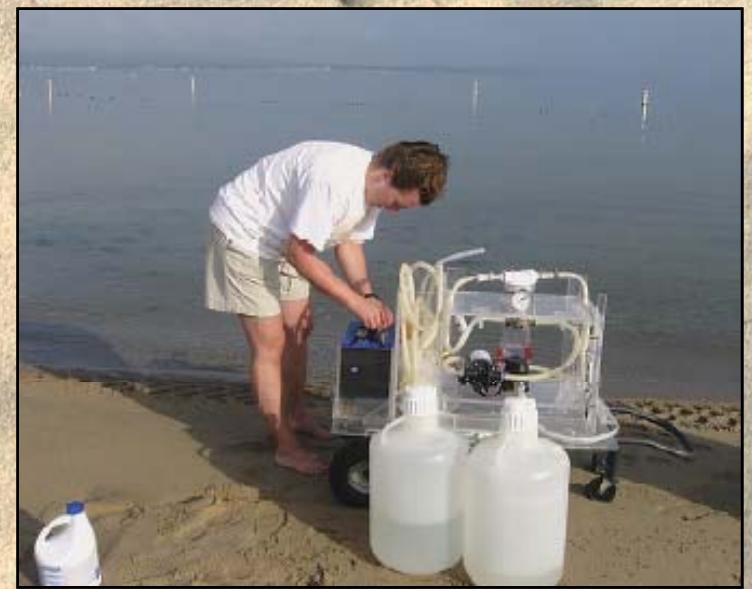
TWC staff taking water samples for USGS

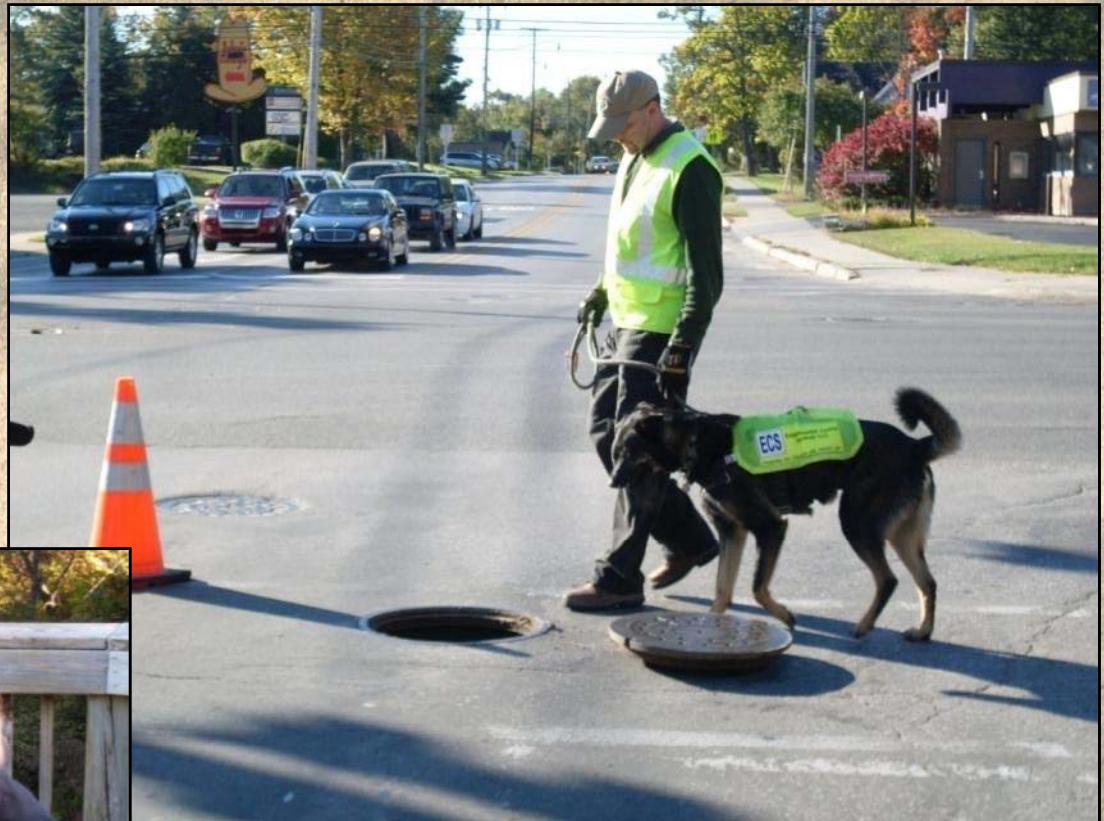
Above: Scott and Sable inspecting a drain in Traverse City

- Trained to detect human sewage and /or detergents in water
- Samples ‘sniffed’ up storm drain line – can pinpoint sources
- Fall 2010 and Spring 2011, results immediately

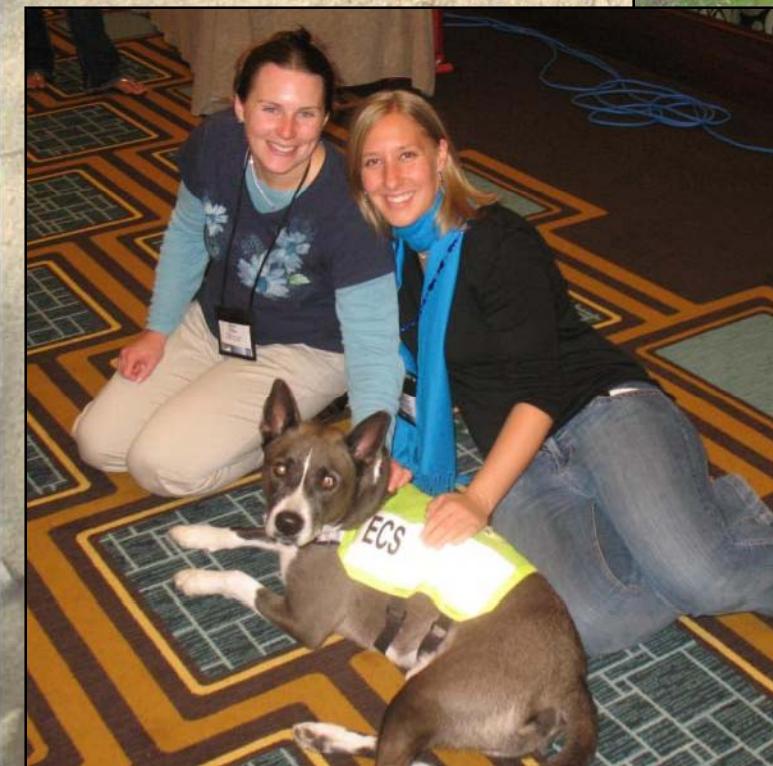
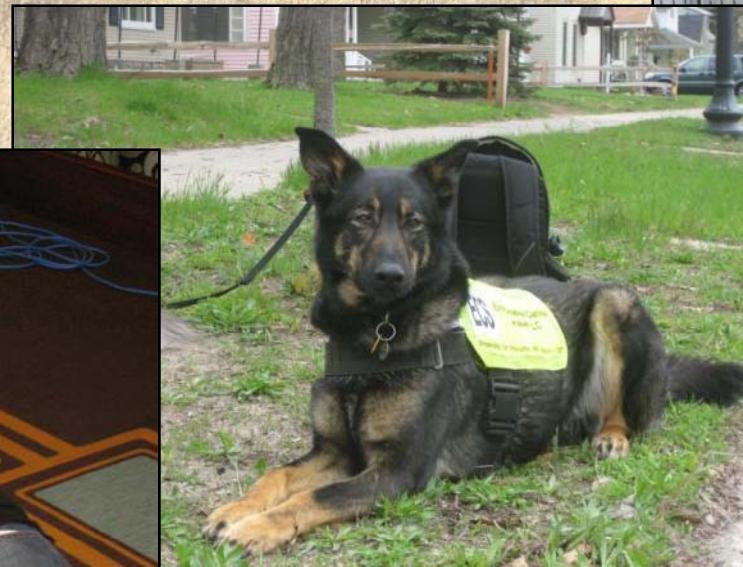
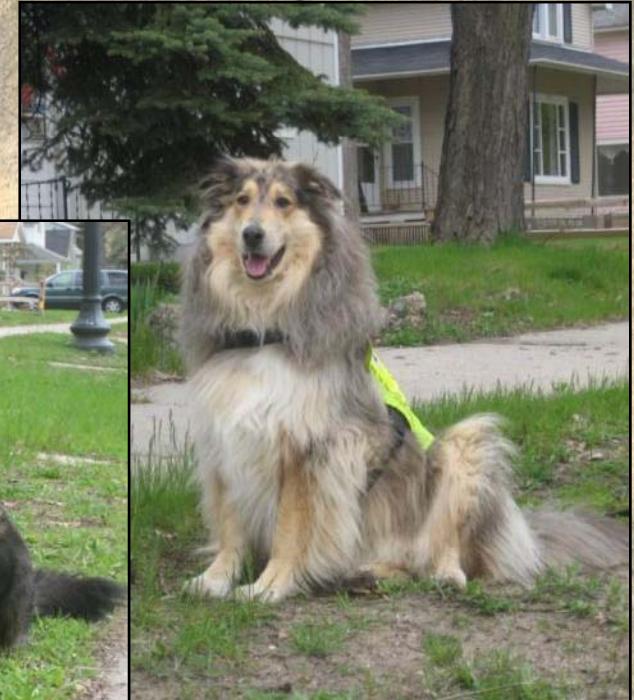
Above-right: Logan ('sits' when he detects)
Above: Sable ('barks' when he detects)
Left: TWC staff and Sky ('barks' when he detects)

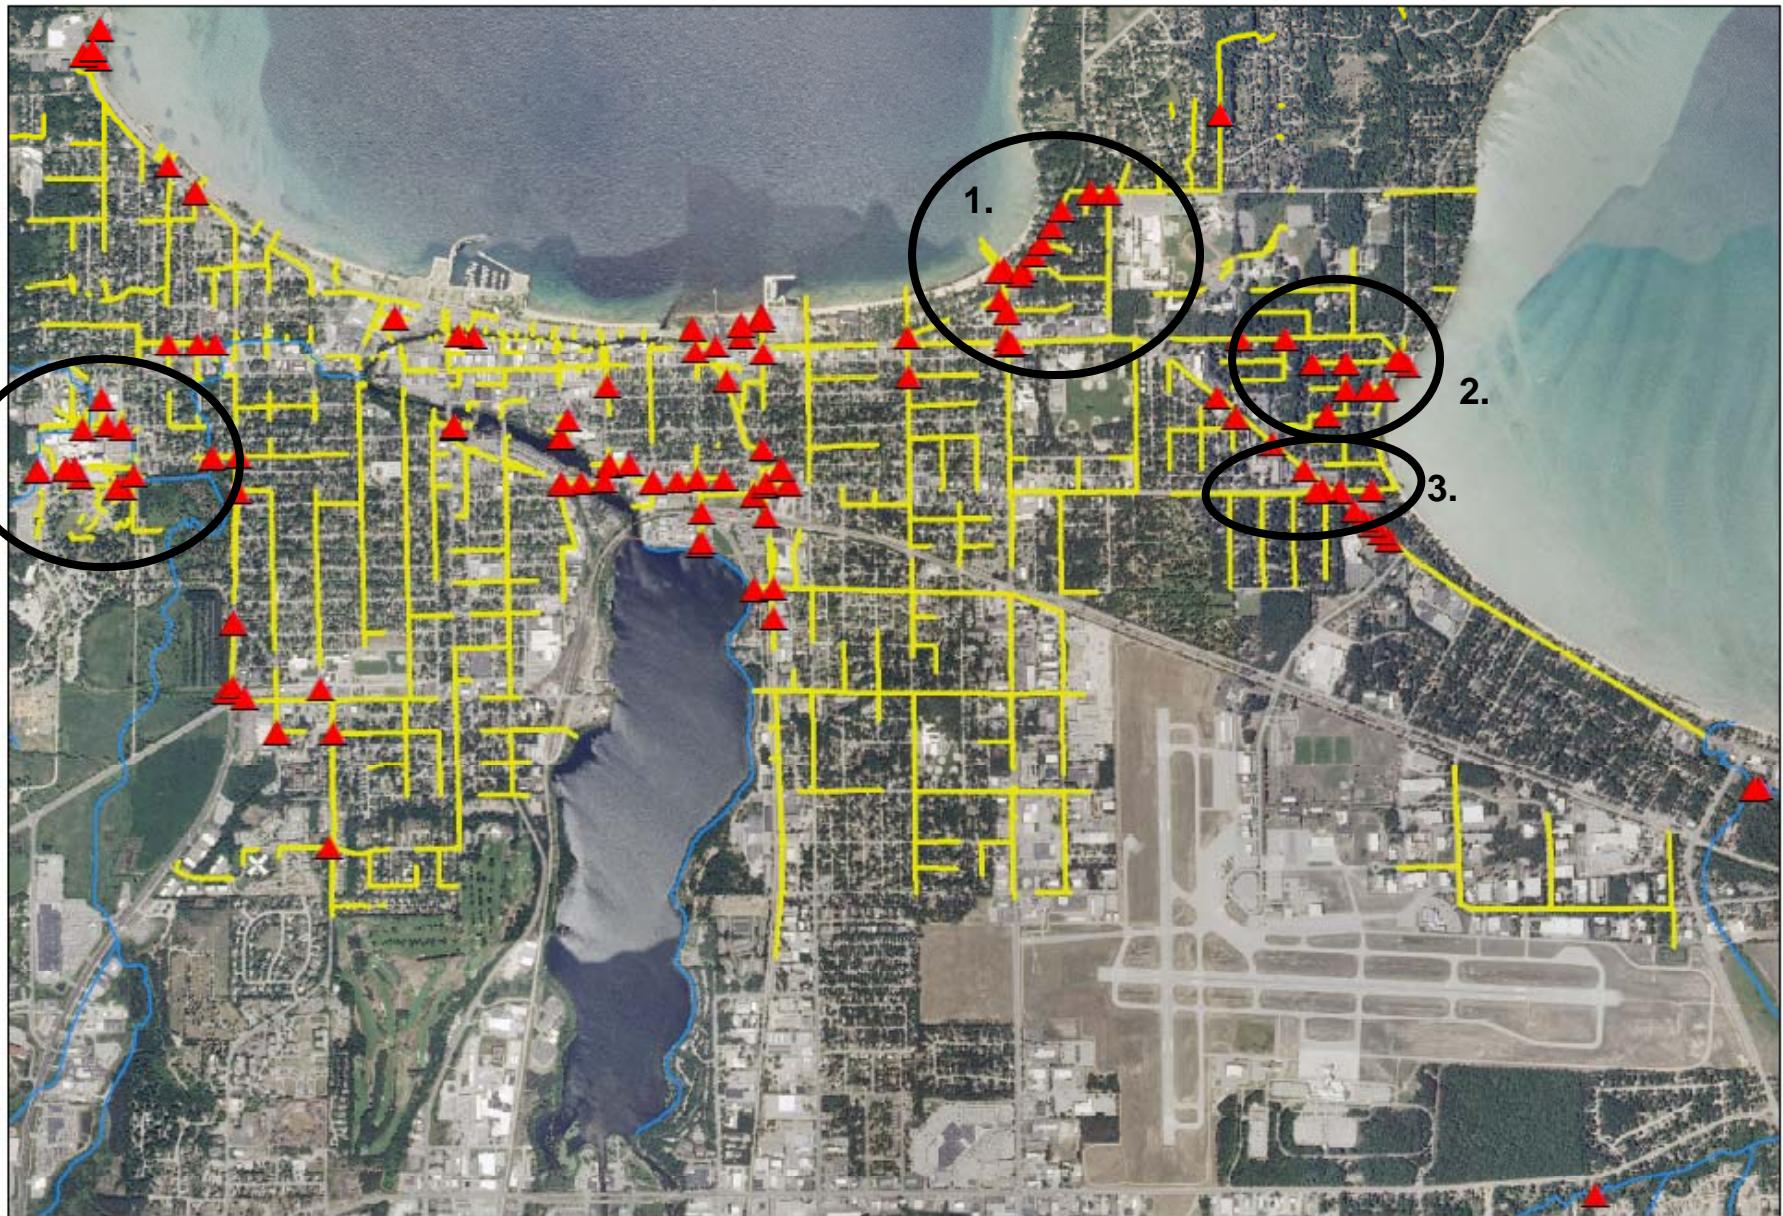
K-9 Positive Hits on the City of Traverse City Stormwater System May 2011

▲ K-9 Positive Hits
— Streams
— Storm Reach Scaled

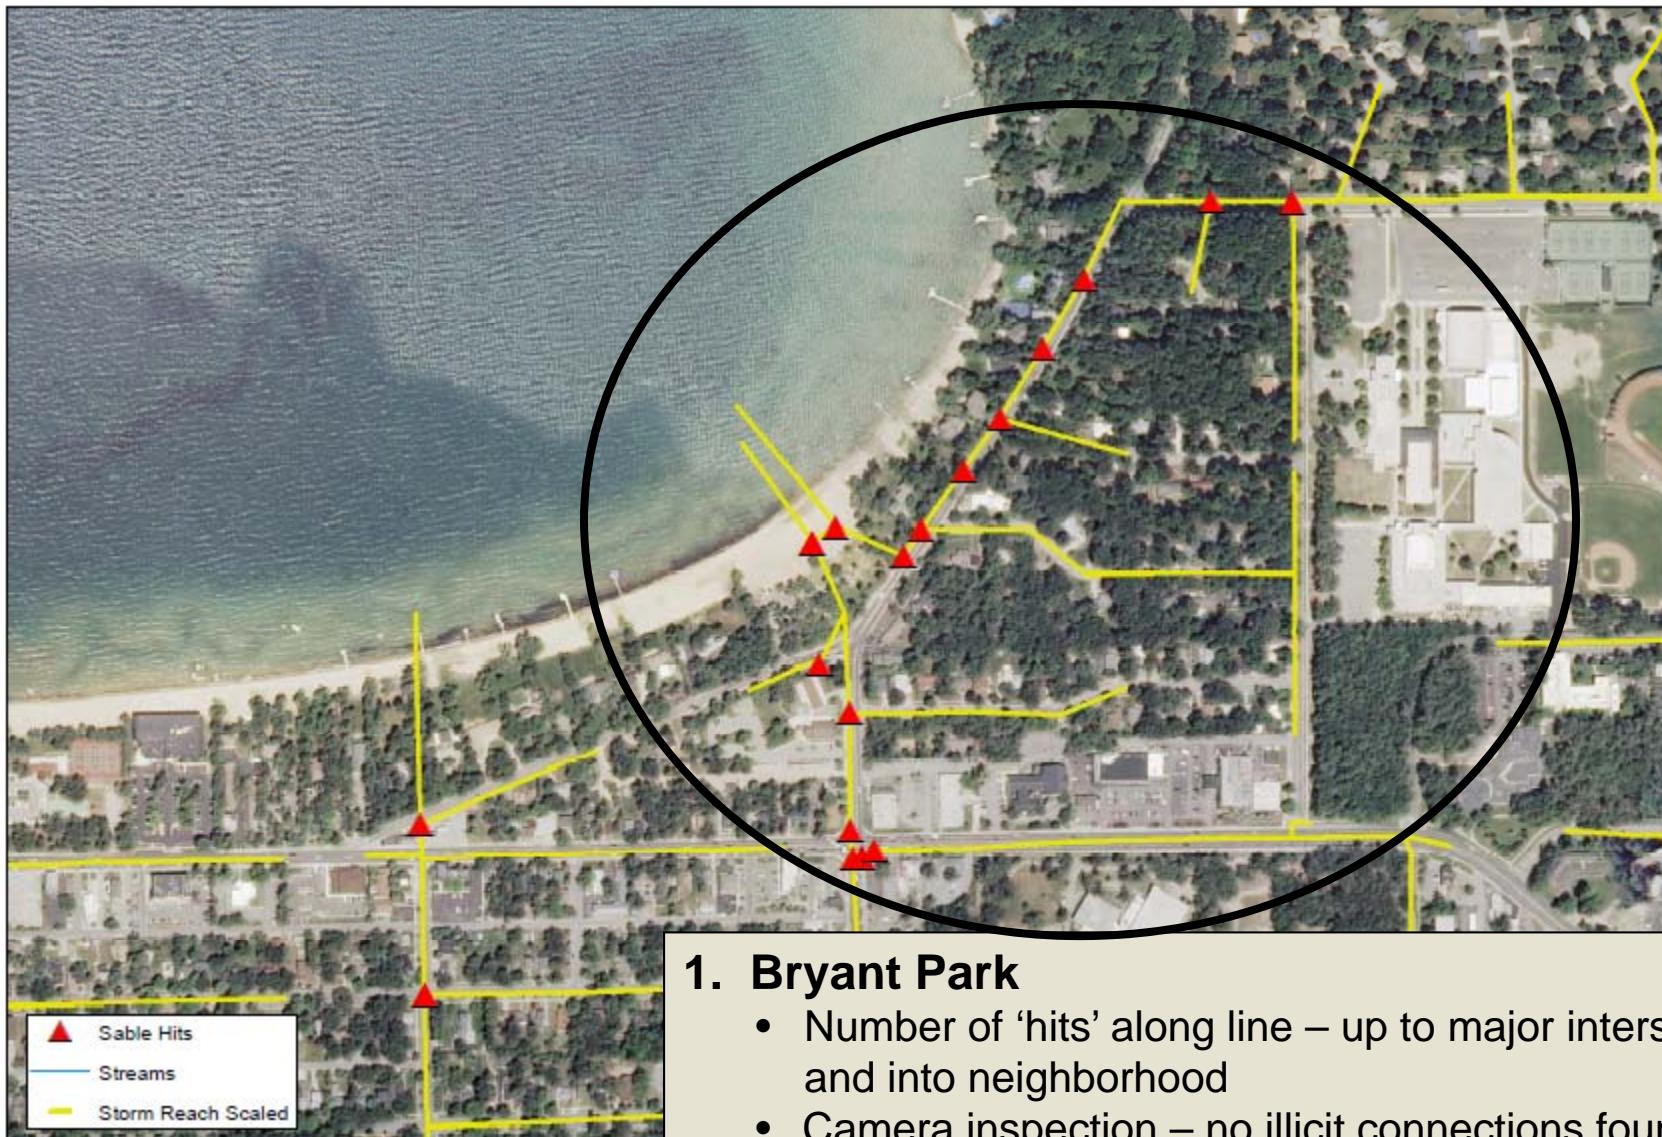
Positive Human Fecal/Surfactant Hits in the Traverse City Stormwater System October 2010

1. Bryant Park

- Number of 'hits' along line – up to major intersection, and into neighborhood
- Camera inspection – no illicit connections found
- Smoke tests – will take a while, busy intersection
- Illegal septic systems?
- Leaking sanitary pipes getting into storm drain?

2. East Bay Park

- Number of 'hits' along line – up into neighborhoods
- Possible b/c of excessive car washing
- Interference from lift station in vicinity
- Camera inspection – no illicit connections found
- Leaking sanitary pipes getting into storm drain?

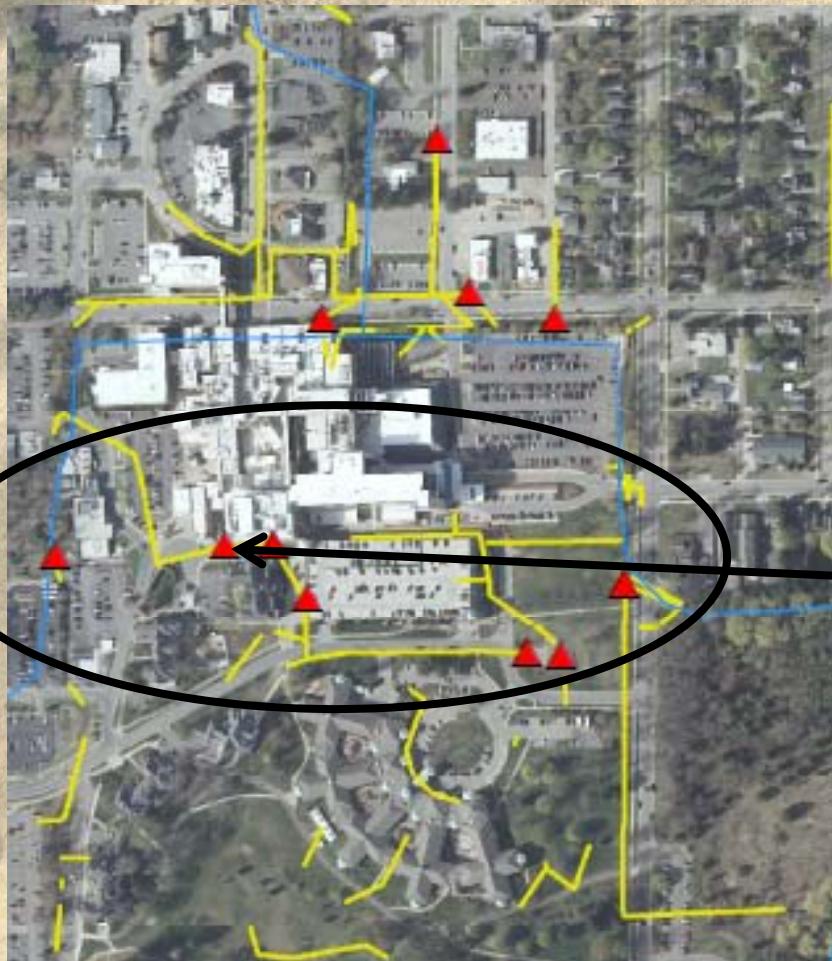
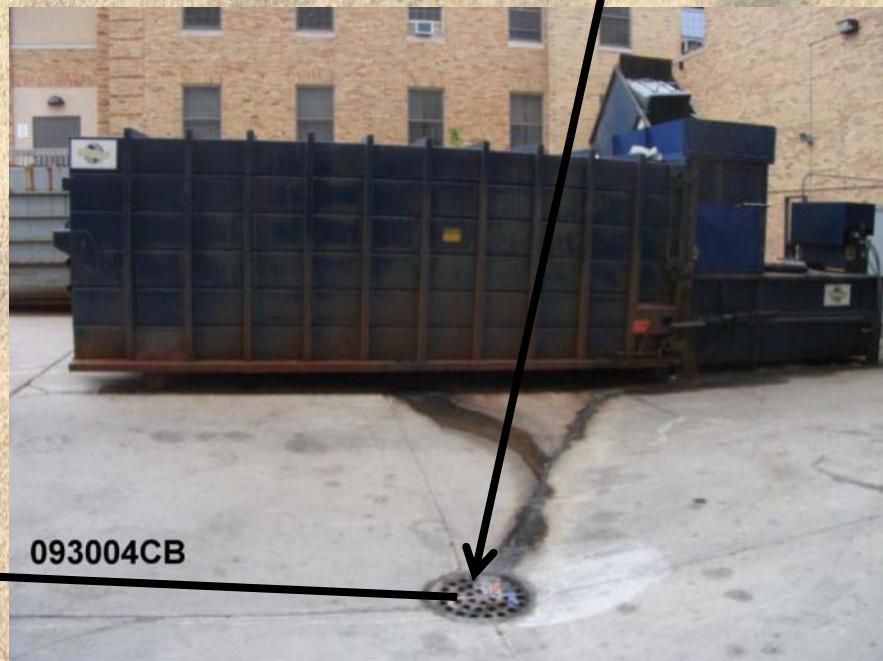
4. Munson Hospital

- Leaking dumpster and trash compactor in loading/unloading area
- County health department and Munson officials notified
- Problem fixed within a week
- Hospital also put new cleaning measures in place (for wayward trash)

E.Coli sample taken from drain greater
than 10,000 col/100mL

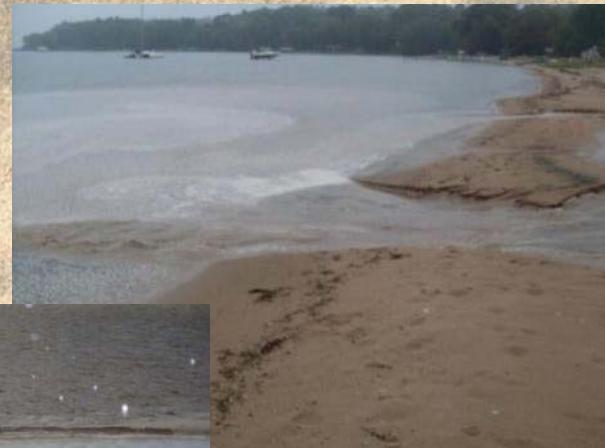
Storm drain overflow at park would frequently 'blow it's top'

- Bacterial contamination of nearshore waters
- Public health risk
- Overflowing storm drain

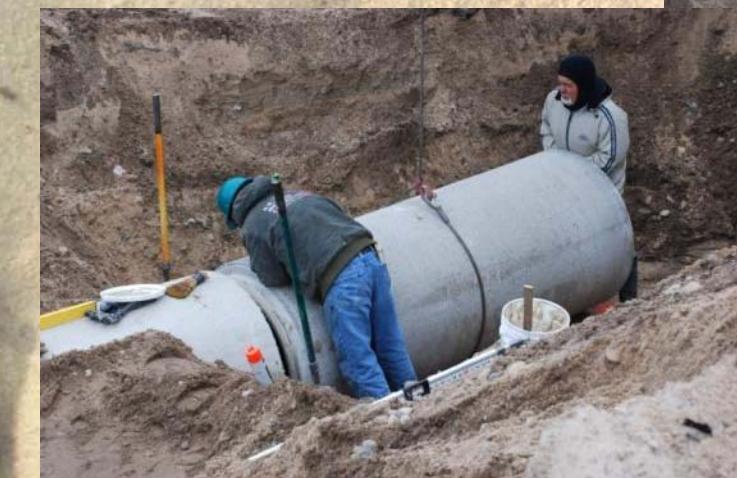
Fall 2011: New drain connections installed to help prevent the system from overloading, also provide a diversion structure to treatment system

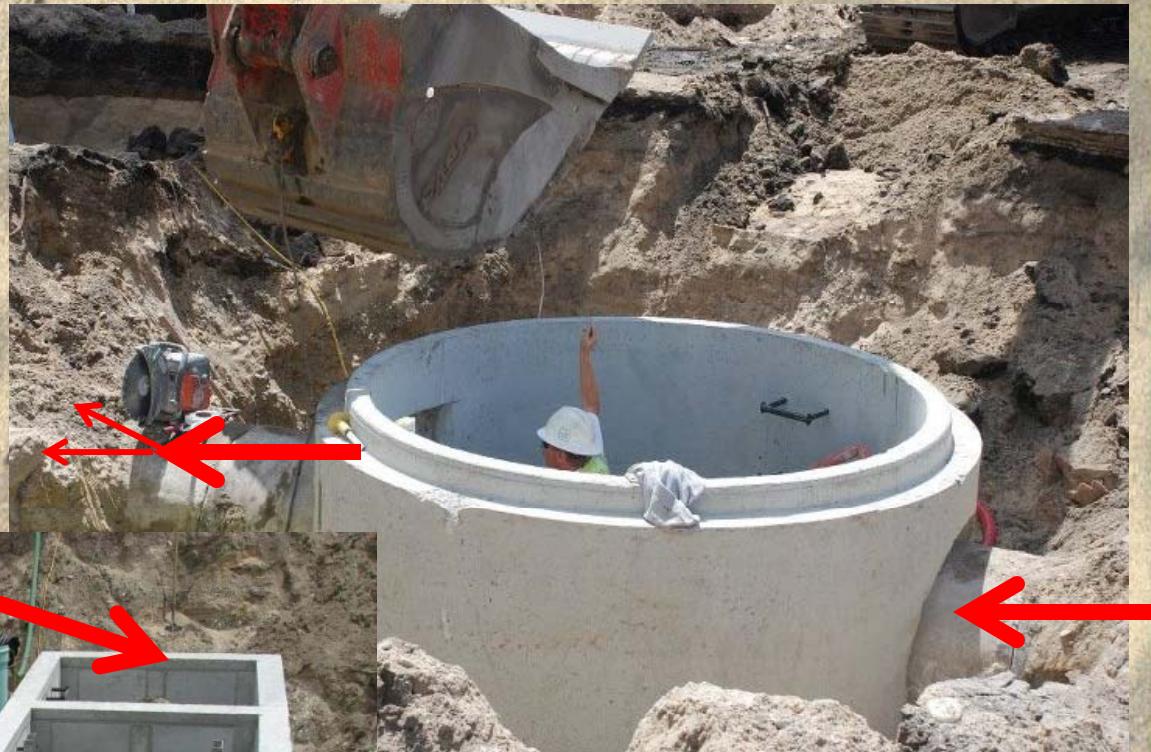
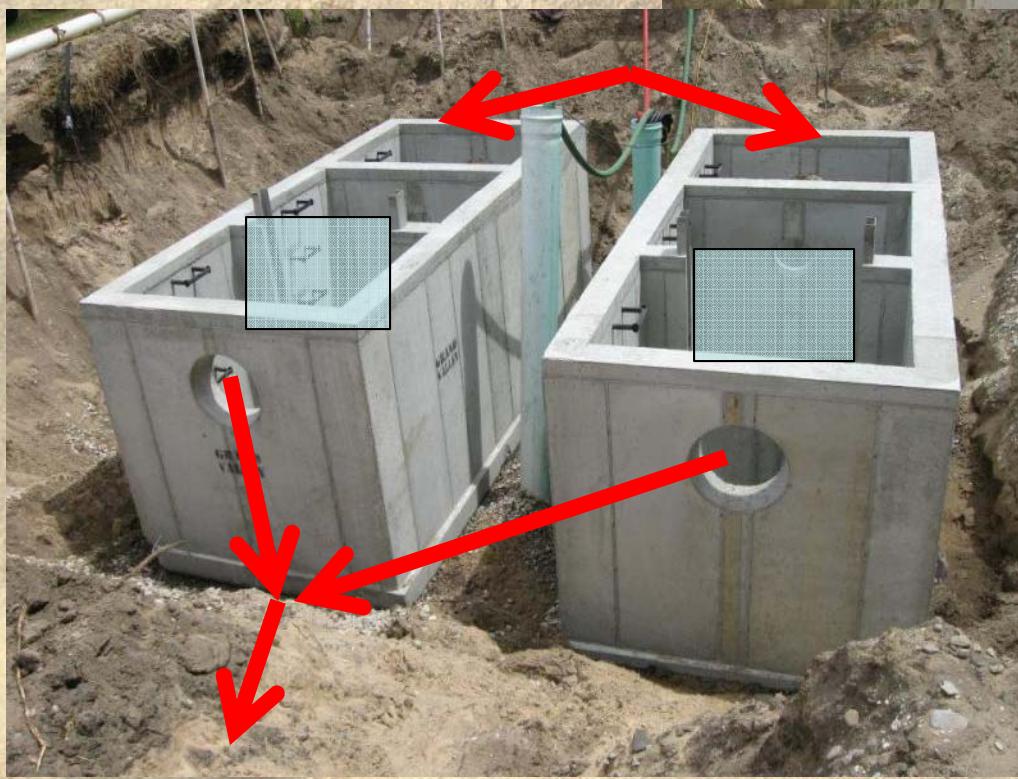
Right: Runoff is diverted to this oil/grit separator to settle out heavy solids

Left: Runoff then flows through these concrete structures to further settle out solids, a screen structure will be between the 2nd and 3rd chamber to filter out things such as cigarette butts and pine needles
